# TECHNICAL INFORMATION BULLETIN

## ABRASION RESISTANT BELTING

### INCREASING THE WORKING LIFE OF YOUR CONVEYOR BELTS

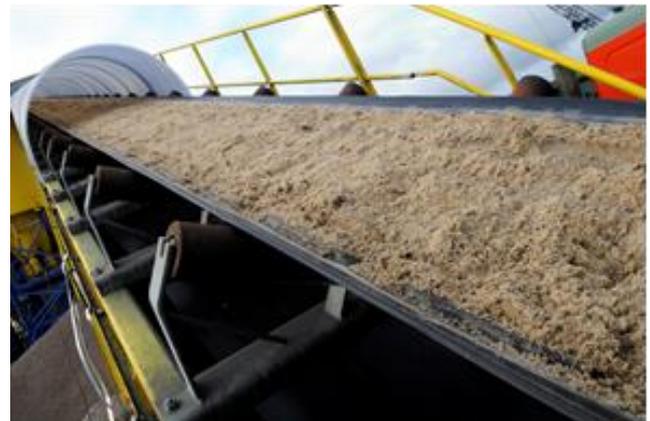
Misaligned drums and idlers cause extra wear

Wear on the bottom cover of the belt is mainly caused by the friction contact with the drum surface and idlers. The rate and uniformity of this type of wear can be adversely affected by many other factors such as misaligned or worn drums and idlers set at incorrect angles. Factors such as ozone degradation (cracking) or an unclean environment where there is a build up of waste material can accelerate wear. Belt cleaning systems, especially steel edged scrapers, can also cause wear to the top cover surface.

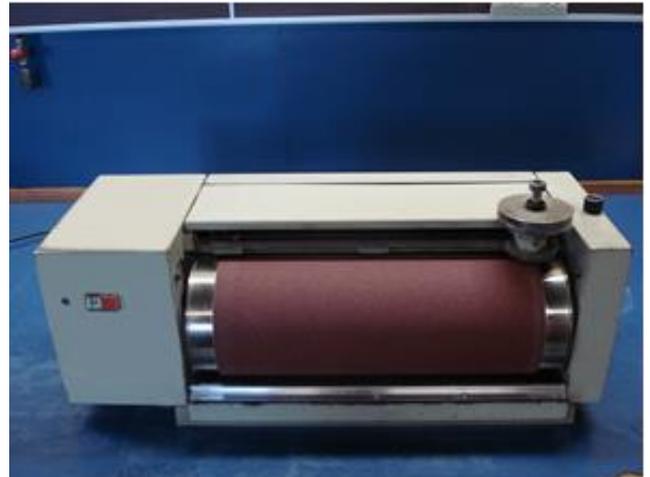
ISO /DIN Abrasion testing machine.

There are two internationally recognised sets of standards for abrasion, ISO 10247 (H, D and L) and the longer-established DIN 22102 (Y, W and X) standards. In general terms, DIN Y relates to 'normal' service conditions; DIN W for more abrasive materials and DIN X for resistance to cutting, impact (from high drop heights), abrasion and gouging resulting from large lump sizes of heavy and sharp materials.
